CASE STUDY: 15 -17 CROSSGATE CUPAR

BRIEF: Shop front reinstatement and repairs of category C-listed tenement building for 5 owners making use of the Cupar Conservation Area Regeneration Scheme/ Town Heritage Interest (CARS/ THI) grant funding.

DATE: 2015-20 **VALUE:** £85,000

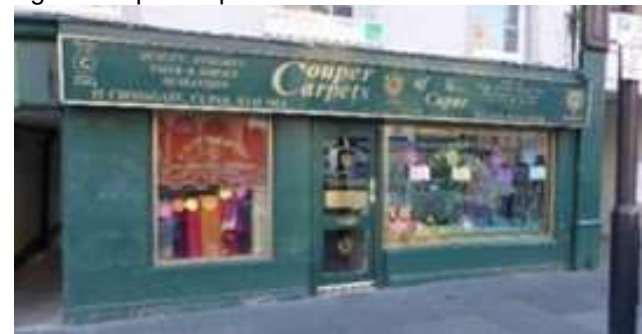
The shopfront stone had been painted to match the Couper Carpets business brand green and a surface film of white paint to the pend side had started to peel away. Above the shop to the front a light grey masonry

Fig 4 Shop front before works

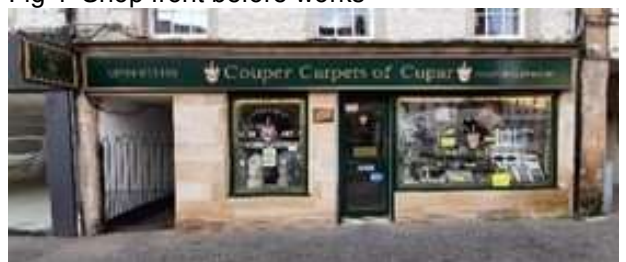
Fig 5. Shop front after works

from the sun. I investigated this but was not able to design a satisfactory solution because of the restricted height, which was the reason that the stone cornice was removed in the first place. The shop front intervention that I proposed involved the removal of the existing canopy box and sign, removal of green paint to frontage, reinstatement of the stone cornice (Fig 57), replacement of metal framed windows with timber double glazed units, an overhaul and coordination of the projecting sign, the reinstatement of a fascia sign (Fig 86) and reconstruction of the gate to the pend (Fig 72, 73).

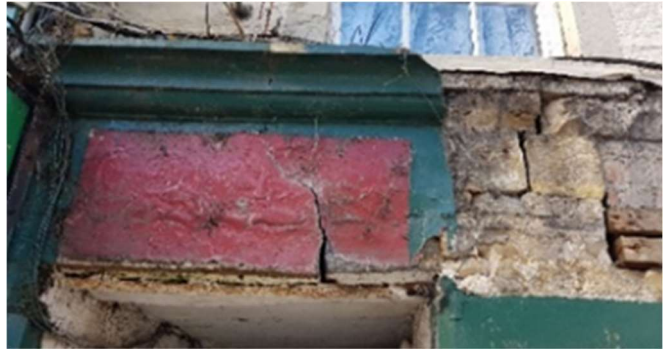
Fig 6. Existing cornice during works

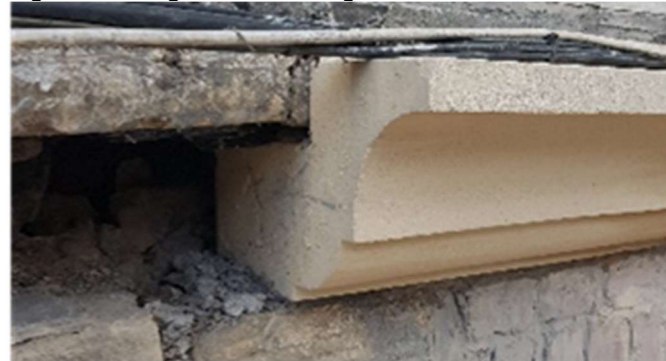
Fig 7. Reconstructed cornice during

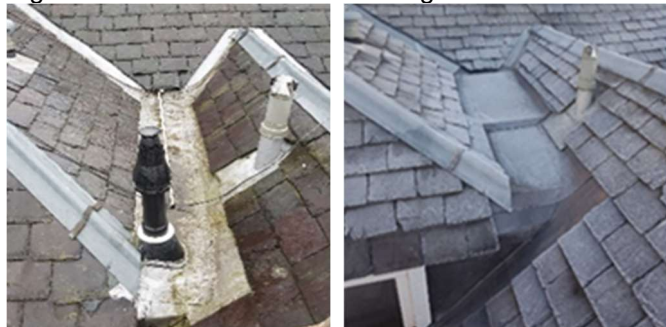
Fig 8 and 9. Gutter detail before and after

I recommended that the rainwater goods needed an overhaul, and I came to understand that the below ground drainage required clearing out as this was periodically backing up. I also recommended that the masonry to the rear required vegetation growth removed, some cracked lintols rinned and one over the pend replaced (Fig 73), extensive re-pointing was required replacing localised cement mortar (Fig 67) which had accelerated the decay of the sandstone and a limited number of stone indents (Fig 75,77) were recommended.

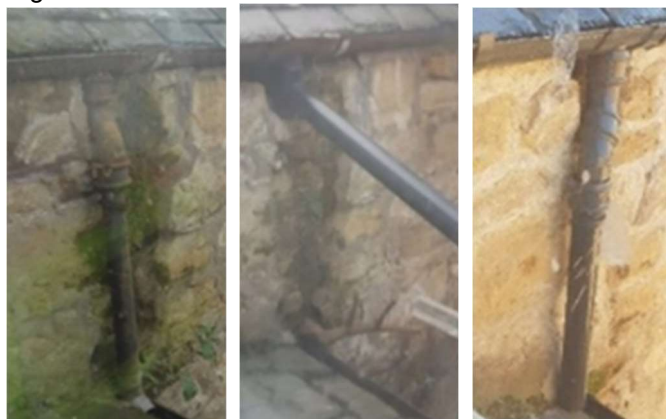
Fig 10 and 11. RW goods before during and after works

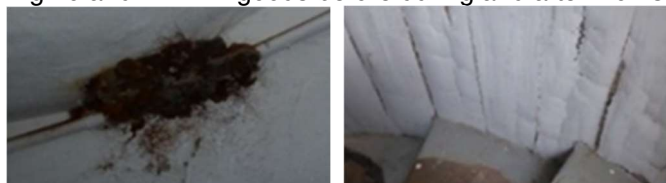
The dry rot evident in the tenement stair (Fig 63, 63) and a second-floor flat window surround (Fig 65) required removal. I brought in a timber treatment specialist who quoted for removal based on visual survey, they offered an intrusive investigation, but the owners opted to wait until funding was in place before progressing this. The specialist's intrusive investigation progressed as part of the construction phase and found that the dry rot had spread from roof level to first floor level (Fig 66, 68, 69) and the cost increased by c600%. To keep control of the costs I proposed, and the owners' agreed, for the main contractor to carry out the dry rot removal on the basis that there would be no guarantee, water ingress was stopped, we removed 'as much as necessary and as little as possible' of the affected timber, we treated the adjacent remaining timber with same treatment proposed by specialist and the new timbers were isolated from the masonry thus saving the client cost and minimizing the loss of historic fabric. As part of this investigation, the contractor found that the first-floor bathroom window WC recess which had been carved out of the corner of the masonry stair tower and had no adequate support (Fig 70) and so this had to be made good, with advice from a Structural Engineer I brought in, as a matter of urgency (Fig 71) and the bathroom redesigned accordingly.

Fig 12 and 13. Dry rot fruiting body, cubed timber in stair

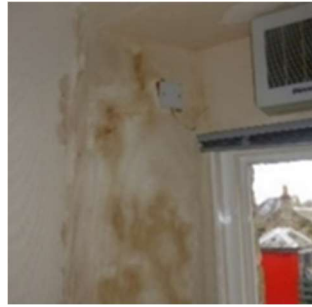
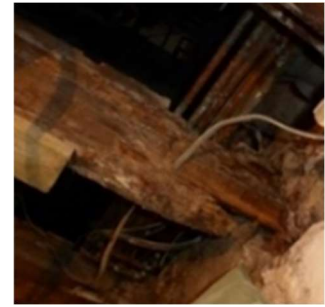
Fig 14 and 15. Dry rot staining, timber decay

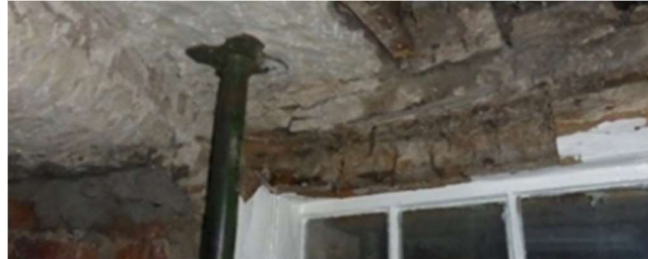
Fig 18. Dry rot cubing to flat entrance lintol

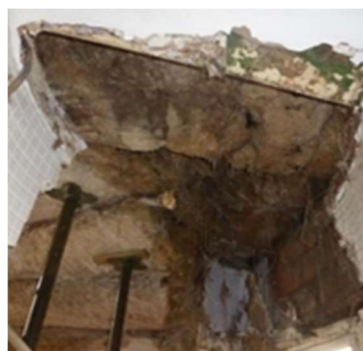
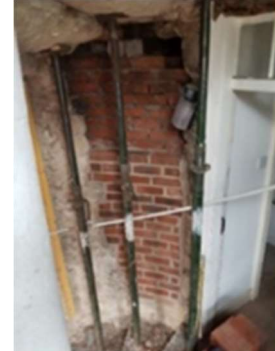
Fig 19 and 20. WC unsupported recess and brick infill

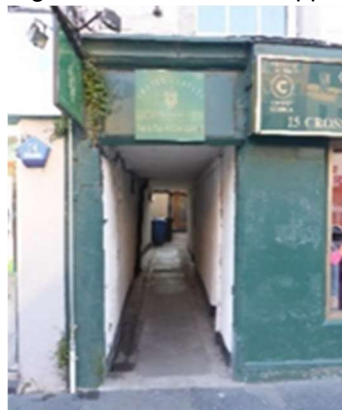
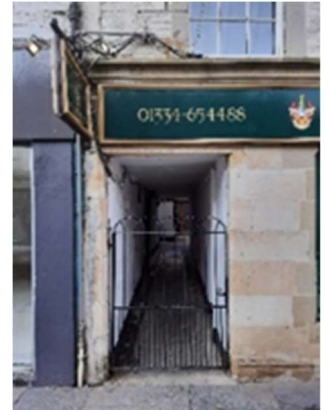
Fig 21 and 22. Pend before and after, reconstructed gate

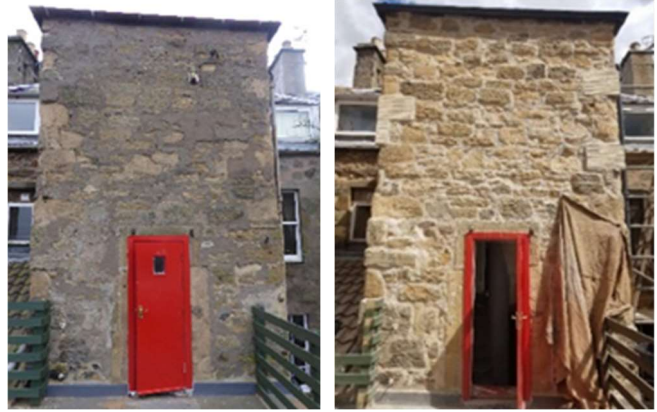
Fig 23 and 24. West stair wall before and after

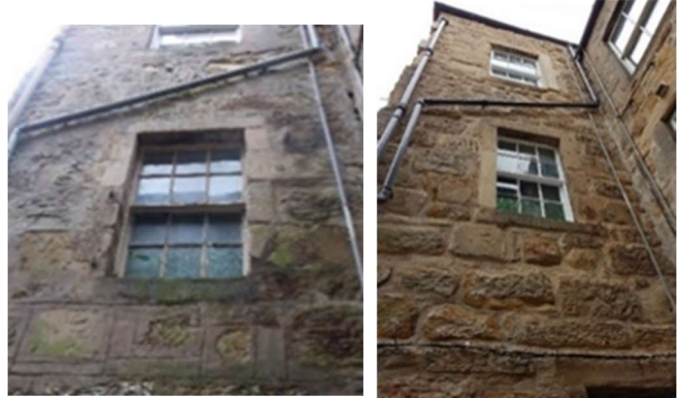
Fig 25 and 26. South stair wall before and after

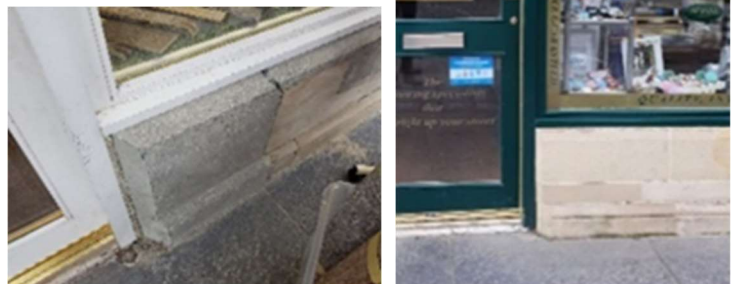
The ashlar frontage had the brittle paint removed with a scraper before polishing to match the existing stone, with carborundum polishing disc and paper. This revealed concrete repairs (Fig 78) to the shop window surrounds which were repaired with ashlar stone indents (Fig 79). The stone used was Blaxter stone for reasons given above. The mortar used was a non-hydraulic lime putty mix consisting of 2(aggregate):1(lime) mix NHL 2 Otterbein and silica sand. The mortar specification ensured that it could be used in thin ashlar beds whilst also being more porous than the stone for the reasons given over.

Fig 27 and 28. Concrete infill and ashlar reconstruction

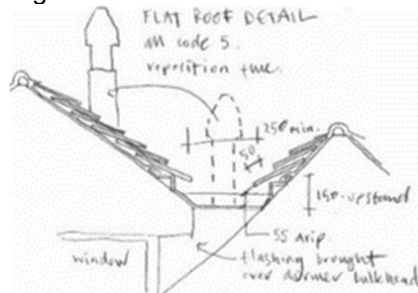
Fig 29. Gutter sketch detail
