**CASE STUDY: 8 BONNYGATE CUPAR**

**BRIEF:** Shop front restoration and repairs of category C-listed tenement building for three owners making use of the Cupar (CARS/THI) grant funding.

**DATE:** 2016-19 **VALUE:** £70,000

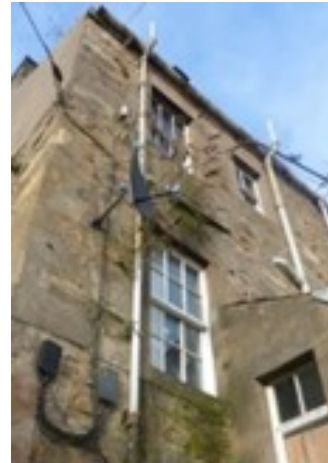
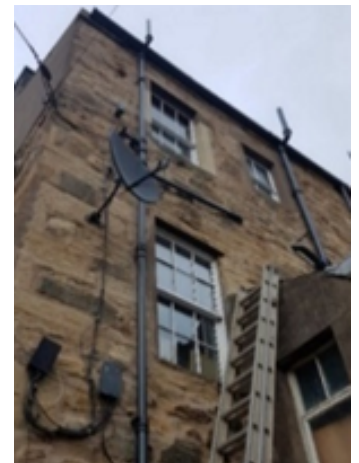
Fig 6 and 7. Rear elevation before and after

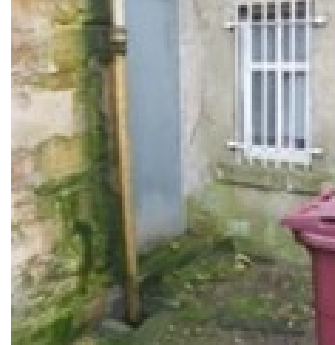
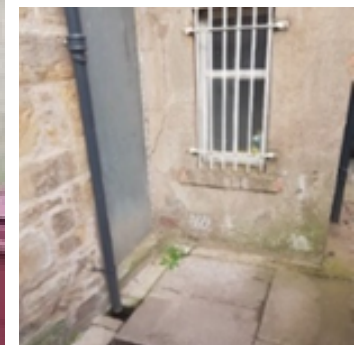
Fig 8 and 9. Failed downpipe before and after

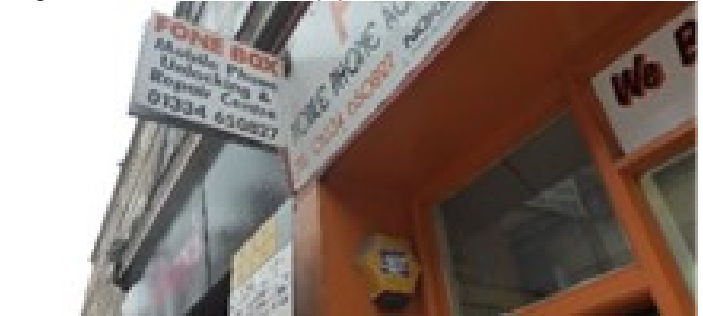
The original ground floor central shop was subdivided into two units c1970s and the upper living accommodation, accessed via a pend and external stairs to first floor level, was presumably subdivide into two flats at the same time. The building has HISTORICAL significance as it was the original office and home of Robert Tullis the founder of R Tullis & Company which today is known as Tullis Russell. In 1801 he bought the property and started a bookshop and bindery (Fig.2), in 1803 he started a printing press and publishers, in 1809 he bought Auchmuty Paper Mill (near Markinch) and in 1822 he started the Fife Herald (Fig.3). Originally the shop had a central entrance with fluted pilasters, and large windows both sides with panelled stallrisers below. The shop was sub divided into two units (c1960) with separate entrances thus losing the original central pilastered entrance and stallrisers, but the original fascia sign and console brackets survived albeit covered with oversized fascia board and plastic signs, with an unsympathetic projecting sign (Fig.10) fixed back through the fascia.

Fig 10. Shop front before works

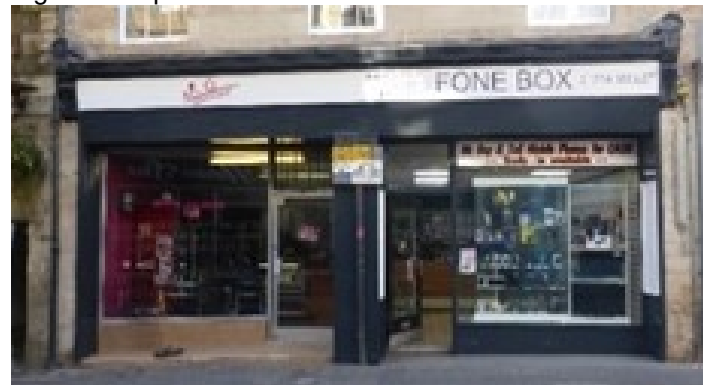
Fig 11. Shop front after works

The shop works therefore included removing the oversize plastic and inappropriate projecting sign, restoring a console bracket renewing the lead flashing over, provision of new fascia sign in proportion with the original, new timber cladding boards to entrance recesses and under fascia sign, to match boards revealed during works with all woodwork painted in an anthracite grey generally and off white to the fascia sign for shops own sign to be hand painted all to provide a unified appearance of the original shop frontage (Fig.11).

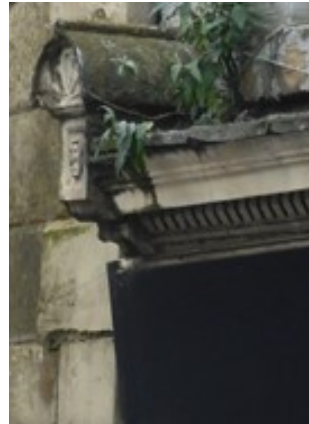
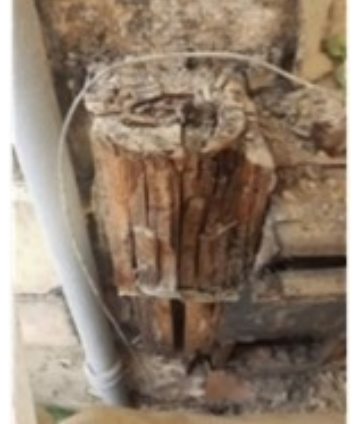
Although the fascia sign had survived the left-hand console bracket had decayed due to exposure to rainwater from blocked downpipe (Fig.12 and 13). The initial joiner sub-contractor was not able to reproduce a replacement console bracket but after a joint effort by me and the main contractor we found a joiner who was able to reproduce the console bracket (Fig 14 and 15) and replaced the lead flashing.

Fig 12 and 13. LH console bracket before and during works

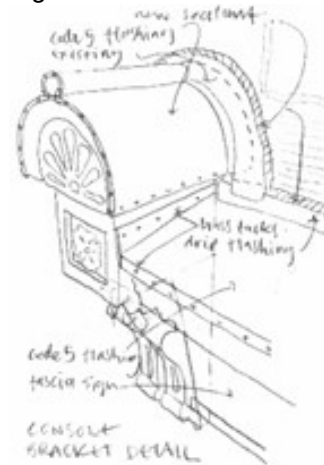
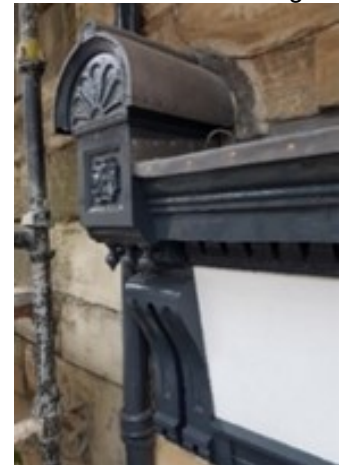
Fig 14 and 15. LH console sketch and after works

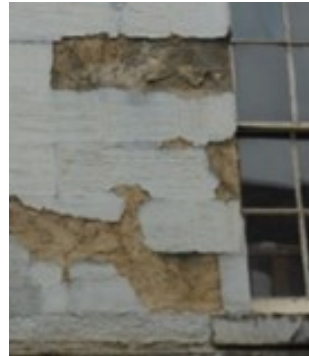
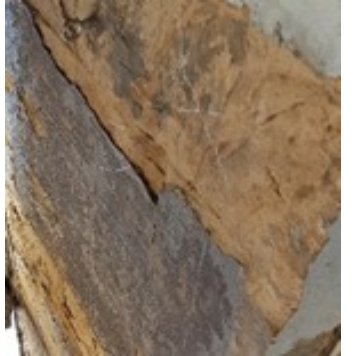
FHBT allowed the saving that was made on the shop sign to be used on the stone repairs to the frontage. When the thin cement coat and loose paint was removed, we found that additional stone indent repairs were justified as there had been considerable decay. The bonded multiple layers of paint were removed by specialist paint removers Blastclean Scotland using Tavec 201 Tensid (Fig.18) to loosen the paint and a DOFF water system for removal. I considered acceptable as it was one of the less intrusive options provided in the SLCT's Cupar Stone report referenced earlier.

Fig 16 and 17. Cement/paint before and during works

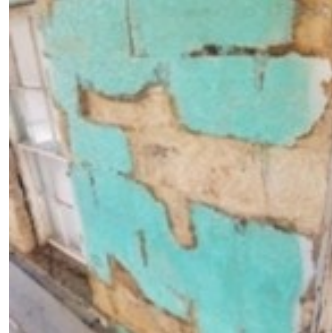
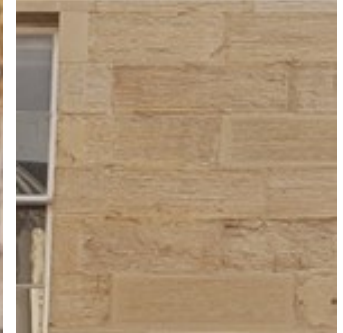
Fig 18 and 19. Paint removal, masonry tooling

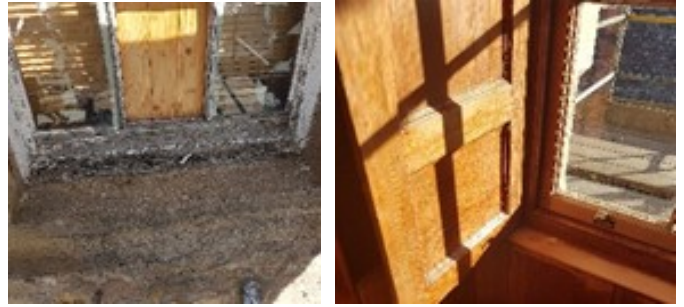
Fig 20 and 21. Window before and after repair

The (mostly) sash and case timber windows had a repair schedule drawn up, which was a combined effort between me and the joiner and included typical repairs such as cill replacement, putty renewal, sanding, and re-painting along with ingos repointing and new sand mastic. One of the windows in the upper flat had a missing pane of glass and required sash repairs (Fig.20 and 21). The upper flat's owner received enhanced assistance due to having limited funds and this along with other thermal improvements were part of a research project.

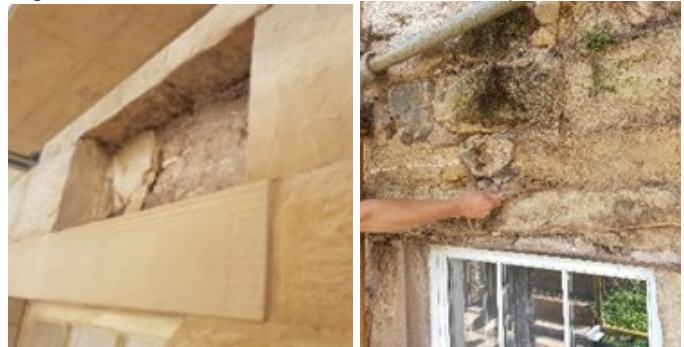
There were two leaks in the slate roof that required local repairs. The rainwater goods required clearing and an overhaul generally using the HES specification for repainting cast iron rainwater goods. The rubble masonry to the rear required significant repointing, vegetation removal (Fig.23) and several stone indents repairs and lintol replacements. Interestingly there was evidence of Mason bees (Fig.26) having used the stone at the rear south facing elevation. The rear shop window steel security grate fixings had expanded and caused stone damage which had the stone repaired and grate repainted and refixed with stainless steel fixings (Fig.27) to prevent this happening again.

Fig 22 and 23. Stone indent and vegetation removal

options referenced in the report. The agreed mortar mix for indent repairs and repointing to rear elevation was a moderately hydraulic lime mortar with a 5(aggregate):2(lime) mix consisting of sand from Angel Park, Ladybank and Otterbein NHL 3.5 to achieve the desired strength and colour. I understand from my training that the mortar specification ensured that it was more porous than the stone so that moisture build up in the wall will be emitted through the sacrificial mortar rather than the stone. Chimney repointing and haunching to chimney pots used a more durable hydraulic lime with similar mix except using Otterbein NHL 5 due to the exposed chimney location. The mortar for the ashlar frontage was 2 (silica sand) : 1 (lime putty gauged with NHL 2). The finish to the mortar was left to semi cure before scraping with a small pointing tool to give a courser textured finish as this increases the surface area, sheds water better than a smooth surface and therefore increases longevity as well as being more in keeping with the original is also more aesthetically pleasing (Fig.27).

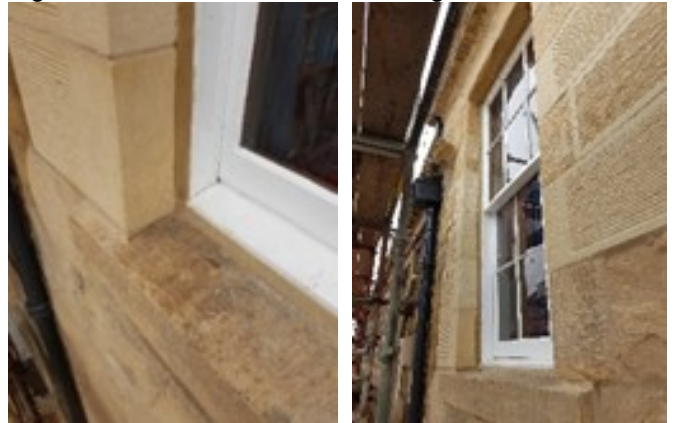
Fig 24 and 25. Front window after works

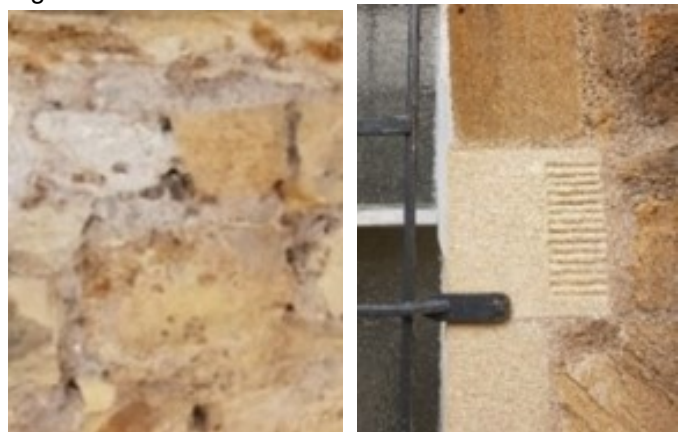
Fig 26 and 27. Evidence of mason bees, grate repair
