**CASE STUDY: BURNSIDE STREET LOCHEE DUNDEE**

**BRIEF:** Conversion of B Listed former Jute Warehouses 5-8 and 14-15 at 55 Burnside Street, Lochee, Dundee into 54 social rented flats for AG Akermo & Sons with Hillcrest Homes.

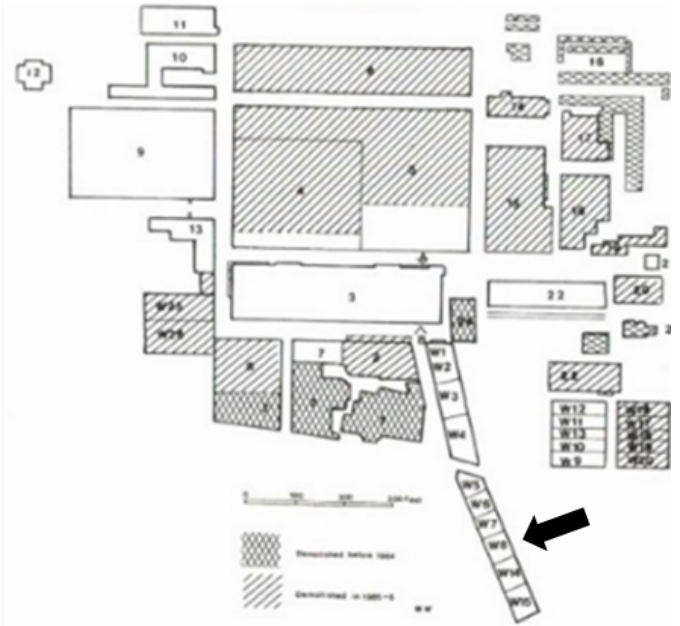
Figure 1. Camperdown works plan c1862 (Watson 1990)

The disused category B-listed (HES. 1986) Victorian Warehouses on the eastern edge of the Lochee Conservation Area (DCC, 2008) were built as numbered Jute Storage Warehouses for the former Camperdown Works (Fig 1 and 2) in two phases, with No 5-8 completed in 1862 and the taller No 14-15 completed in 1882. These are in line with the earlier warehouses 1-4 on the opposite side of Burnside Street which had the railway embankment removed to allow conversion into residential flats in 1993. Soon after the Camperdown Jute Works ceased operation in the early 1980s warehouses 7,8,14 and 15 were adapted and extended for use a Sports Social Club which operated from the mid-1980's to late 1990's.

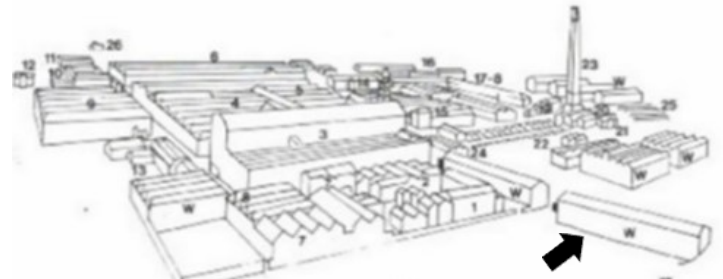
Fig 2. Camperdown works isometric c1900 (Watson 1990)

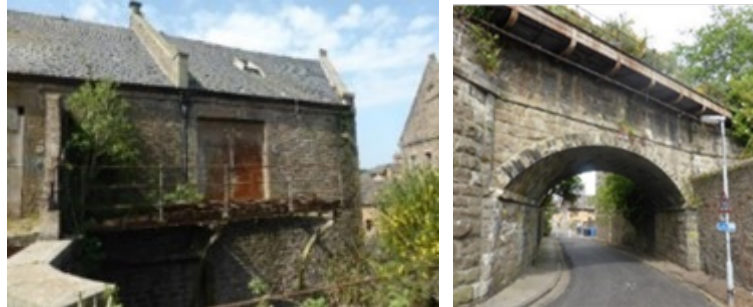
Fig 14 and 15. Warehouse 5 and 6, former rail bridge

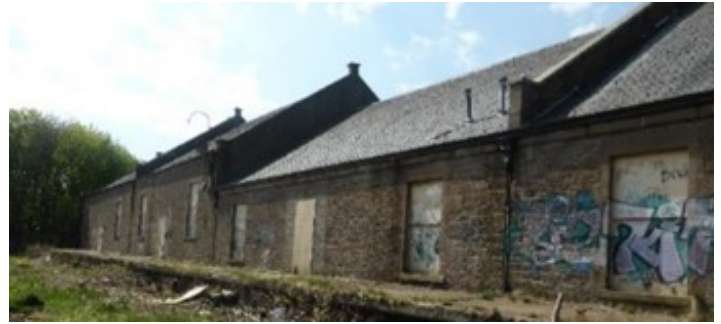
Fig 16. Northeast elevation and former rail platform

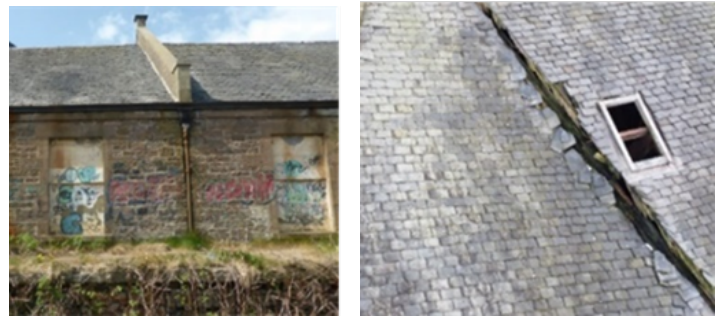
Fig 17 and 18. Graffiti, Warehouse 5 roof collapse

Due to the non-use of the building for circa 20 years it has fallen into disrepair and was listed on the Building at Risk Register in 2010. The building is in sound structural condition except for the roof of Warehouses 5 and 6 where the roof has started to collapse (Fig 18 and 21), and several trusses require closer inspection to allow appropriate repair. The failed and open roof and roof-lights to Warehouse 5 and 6 mean that the risk of collapse, pigeons and hence guano are ongoing safety issues in this area (Fig 20).

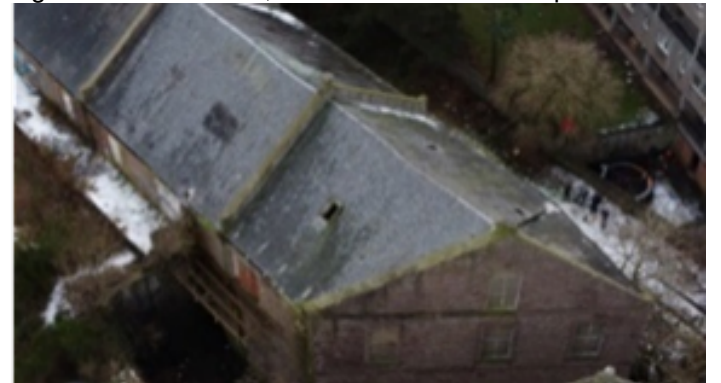
Fig 19. Aerial view of Warehouse 5 and 6

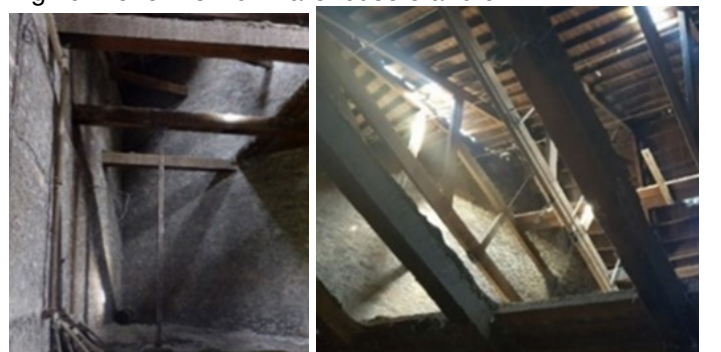
Fig 20 and 21. Internal views of Warehouse 5

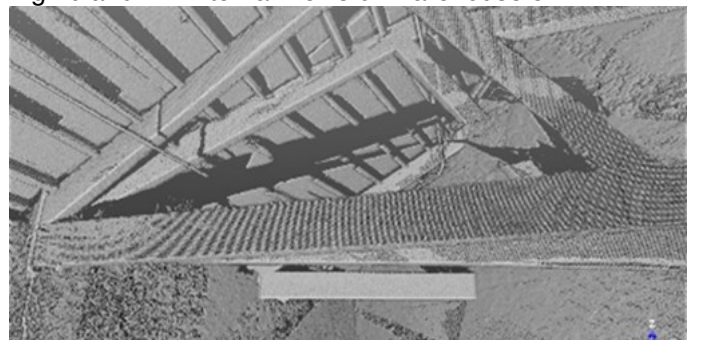
Fig 22. 3D scan, Warehouse 5 decayed roof timbers

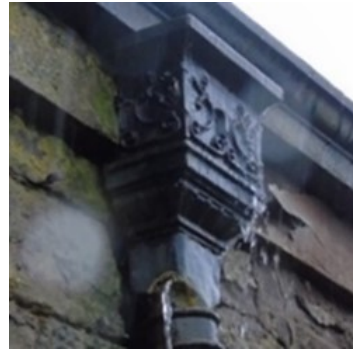
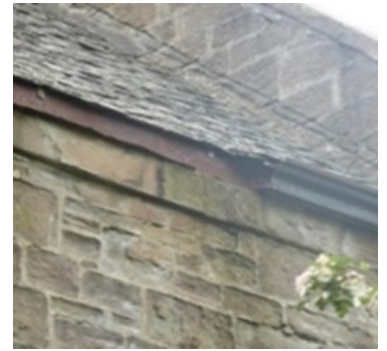
Fig 23 and 24. Failed rainwater goods, cement pointing

The rainwater goods have failed in several places (Fig 23 and 24) and as a result rainwater staining and vegetation growth and masonry decay are at varying stages of development throughout the building. Early roof repair and making good rainwater goods to stop water ingress and halt deterioration is planned as part of the proposed repairs which are due to start January 2023 and are being supported by Dundee Historic Environment Trust (DHET). The schedule of repair works includes making good rainwater goods, making good masonry and mortar exposed when rainwater goods are down, clear guano, provide safe access to the various timbers for structural engineer and timber specialist inspection to allow appropriate repairs to be designed and implemented to ensure structural stability and making good of slate covering, all on a like for like basis.

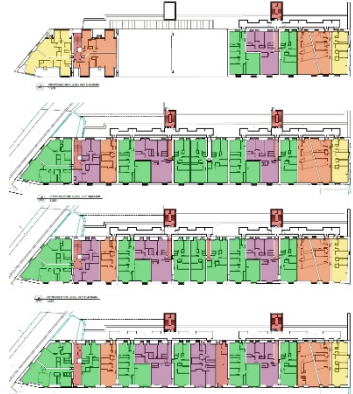
- KEY:**
- Circulation
  - 1 Bedroom 2 Person unit
  - 2 Bedroom 3 Person unit
  - 2 Bedroom 4 Person unit
  - 3 Bedroom 6 Person unit

Fig 27. Flat type diagram

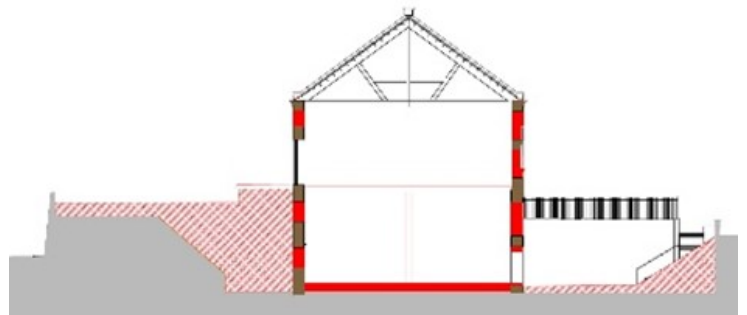
Fig 28 Existing section

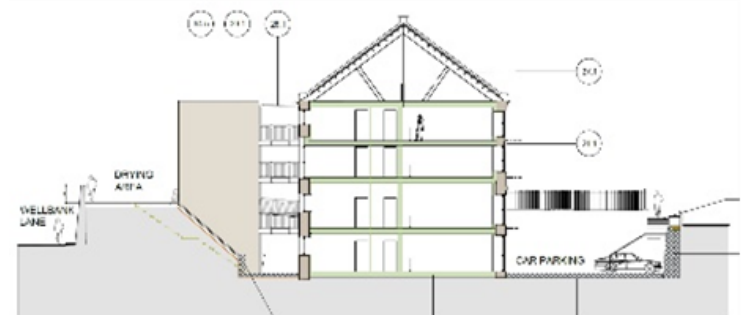
Fig 29. Proposed section

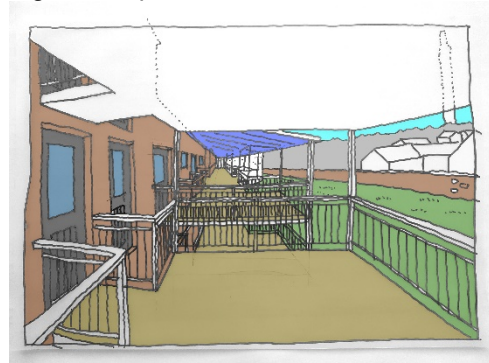
Fig 30. Platform access sketch

fabric (Fig 30) and to help reinforce a distinction between old and new. They are to be on the same line of the railway platform and hence will offer a similar view of the impressive A Listed 'Cox's Stack,' which will reinforce a visual link to the heritage of the place, as well as referencing the rail platform and similar access arrangements used throughout Dundee's history and the local vernacular. Once the mix of flat types was agreed with Hillcrest Homes and I had feedback from the Community Consultation this allowed the design to settle and LBC and Planning Applications were duly submitted and approved by DCC. The proposal includes the removal of the rail platform and removal of some of the embankment to allow light and air to northeast elevation. Warehouses 5 and 6 are to be served by an internal stair due to the restriction imposed by the stone retaining wall springing from the rail bridge which is to remain as will the existing cast iron cantilevered platform to Warehouse 5 as a memory of the rail platform.

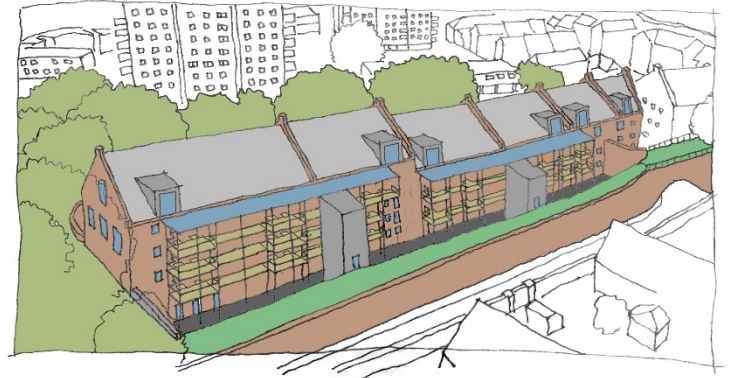
Fig 31. Northeast 3D sketch
