**CASE STUDY: 8 BONNYGATE CUPAR**

**BRIEF:** Shop front restoration and repairs of category C-listed tenement building for three owners making use of the Cupar (CARS/THI) grant funding.

**DATE:** 2016-19 **VALUE:** £70,000

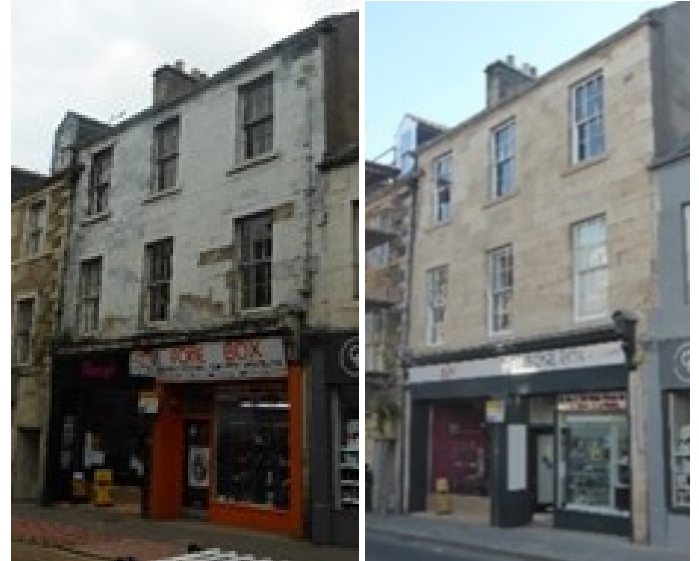
Fig 3 and 5. Bonnygate elevation before and after

FHBT allowed the saving that was made on the shop sign to be used on the stone repairs to the frontage. When the thin cement coat and loose paint was removed, we found that additional stone indent repairs were justified as there had been considerable decay. The bonded multiple layers of paint were removed by specialist paint removers Blastclean Scotland using Tavec 201 Tensid (Fig.18) to loosen the paint and a DOFF water system for removal. I considered acceptable as it was one of the less intrusive options provided in the SLCT's Cupar Stone report referenced earlier.
